Halfway Brook Watershed Stormwater Assessment and Management Plan

Prepared by the Warren County Soil and Water Conservation District
September 1999

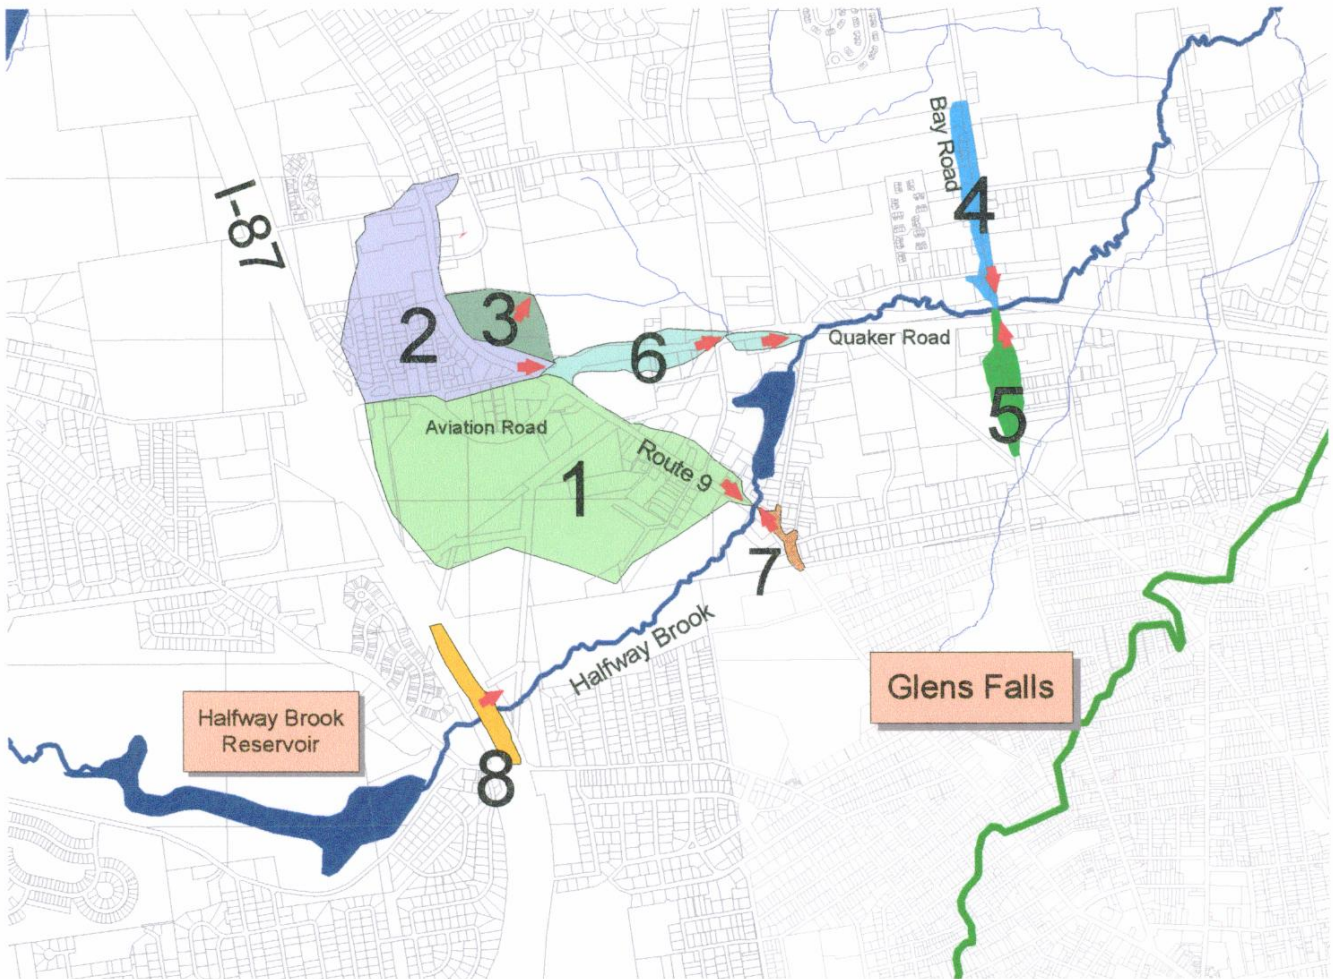
Town of Queensbury - Areas of Stormwater Concern

3. Bay Road. Recent development by a large retail store has reduced stormwater runoff in the area. Bay Road itself is a well traveled road that has some residential development, a community college, a golf course, open space and commercial development. North of the Quaker Road intersection, a retail store was replaced by Lowe's Home Improvement center and their stormwater plan improved to lessen the effects of stormwater on the brook. A number of drop inlets are found which flow into the ACC tributary or Halfway Brook itself. South of the intersection of Quaker Road, residential and a concrete manufacturing plant is found. Stormwater from the area roads empties into the Crandall Park tributary, which flows into Halfway Brook by Cronin Road. (High Impact)

10. Glenwood Ave. Glenwood Ave. borders Halfway Brook along Hovey's Park Pond and the attached wetland to the south. (Low Impact)
11. Cronin Road. Cronin Road is a connector between Bay and Ridge Roads. Bay Meadows Golf Course is the major landowner at this location. Some development at the intersection of Bay and Cronin Roads can be found. A roadside ditch runs to the brook from the west and enters into a rock-lined section, before entering the brook. A few houses are found here as well. This area is heavily vegetated. (Low Impact)

Recommendation - Aviation Road: Stormwater flows down Aviation Road and outlets into the Route 9 drainage line at the intersection of Aviation and Route 9. To improve the water quality coming from this Aviation line, the undeveloped space between Burger King and Mobil Gas on the southern side of Aviation Road could be used as a treatment area. There is approximately 120 feet by 40 feet of grass area that is undeveloped, potentially available for the installation of one or more underground structures in series (i.e. Vortech or similar structure). This would capture approximately 80 % of the stormwater on Aviation Road and treat it. Although these type of underground stormwater improvement structures do little to remove dissolved pollutants, a large amount of road sand, trash, and debris will be removed from the stormwater.

Recommendation - Lower Route 9 Corridor (Aviation Road down to Halfway Brook): Field work and mapping have shown that there is very limited area to undertake stormwater improvements in this area due to the high level of development and high market value of the land. There are two options for stormwater improvement in this area.

Recommendation - Option 1: Using the grass covered state property located in front of Monroe Muffler, a series of underground structures may be installed to control stormwater quality and quantity from this subsurface culvert. Available space in this area is approximately 40 feet wide by 200 feet long, which would be sufficient to control for stormwater quality using the proper structures.

Recommendation - Option 2: Utilizing the front of the Queensbury Cemetery property, a vegetated stormwater detention basin could be constructed to accept the stormwater from this same section of Route 9. This basin could be vegetated with selected species of plants to allow for improved nutrient uptake, which would improve upon the subsurface structure recommendation above. However, the winter and spring dormant plant season will not be able to provide this benefit.

Recommendation: Create a high quality stormwater wetland at the site of the current outlet, and build enough capacity in this wetland to allow it to have water quality improvement qualities. A berm/riser system could be built at the exit of this wetland to provide for larger capacity and retention time, allowing for nutrient uptake and sediment removal.

Recommendation: There is a fairly extensive floodplain for Halfway Brook in front of the Lowe's Warehouse, which could be utilized as a filter for stormwater. The two drainage pipes could be rerouted to outlet into this floodplain, where the stormwater would spread out across this vegetated area and infiltrate into the soil. Building a low berm before the stormwater flow reached the bank of Halfway Brook would allow for a longer retention and infiltration time. This solution would be a relatively simple means to address this issue at this location.

Recommendation: There is a fairly extensive floodplain for Halfway Brook in front of the Lowe's Warehouse, which could be utilized as a filter for stormwater (much like item 6 above). The two drainage pipes could be rerouted to outlet into this floodplain, where the stormwater would spread

1. Hannaford Plaza – the stormwater detention area which was created for control of stormwater coming off of this development could be easily improved at a minimal cost. The outlet culverts are at approximately the same elevation as the inlet culverts, providing for very little capacity in this basin. By installing a simple riser structure at the outlet, the retention time of this basin and its infiltration capabilities would be significantly improved.

Recommendation: The flow from this drainage goes under the Sunoco station adjacent to Halfway Brook. Installing a subsurface stormwater improvement structure at this location (either on the Sunoco lot or in the DOT right of way) would control for almost all of the flow from this three-acre section. With the potential for petroleum-laden runoff from the gas station and auto repair center, a solution which can improve water quality relating to these contaminants (such as Aquashield™) would be recommended.

Recommendation: At the outlet of the culvert which drains the Northway, a berm could be constructed which would route the stormwater and any sediment away from the Brook and into the surrounding woods. There is plenty of area to have this stormwater dissipate into these woods whereby essentially no stormwater would enter the Brook from the Northway. This would be a very simple and quick fix to a primary stormwater input into the Brook.
