# *Watershed Management Plan*

# *Schroon*

# *Lake*

# SCHROON LAKE WATERSHED MANAGEMENT PLAN

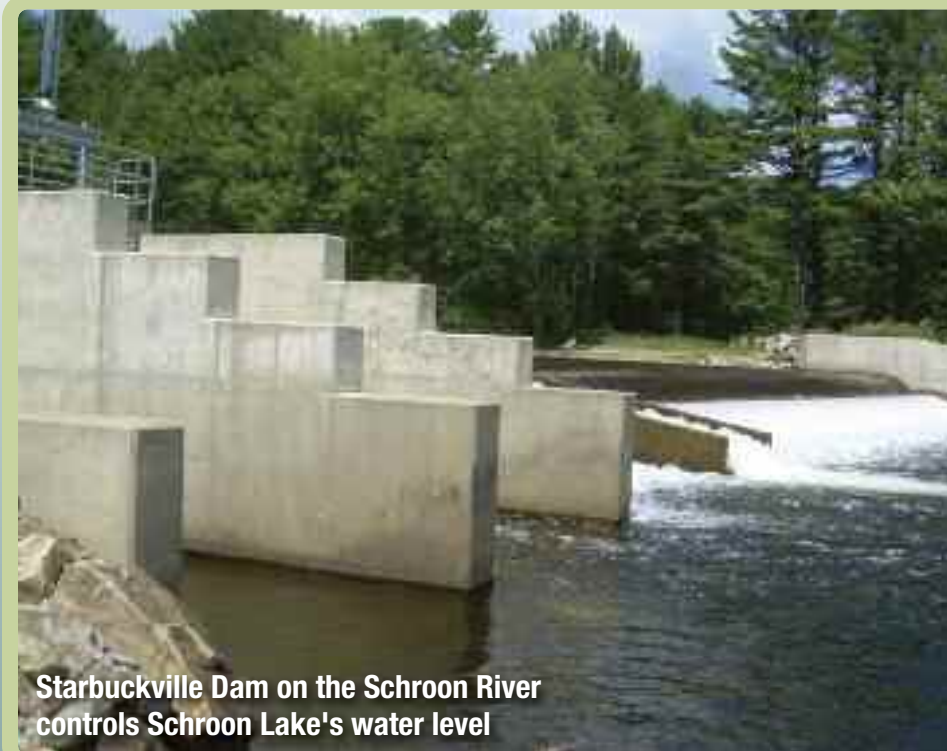
Starbuckville Dam on the Schroon River controls Schroon Lake's water level

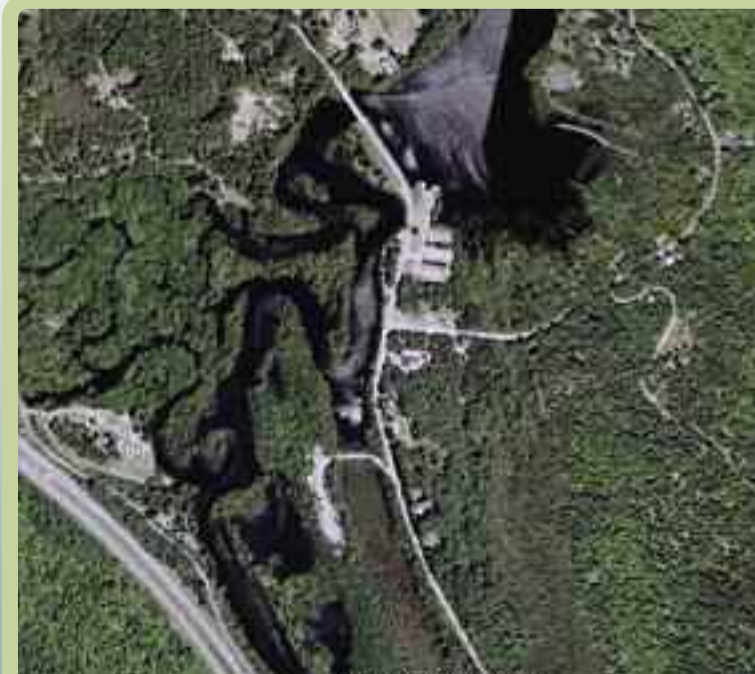
The southern tip (and outlet) of Schroon Lake, has a large and diverse wetland complex. (Google Earth aerial image)

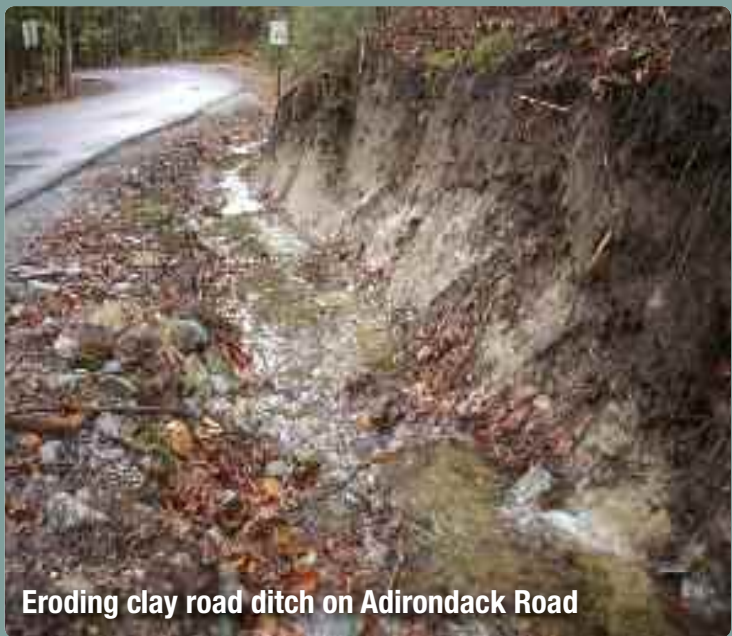
Eroding clay road ditch on Adirondack Road

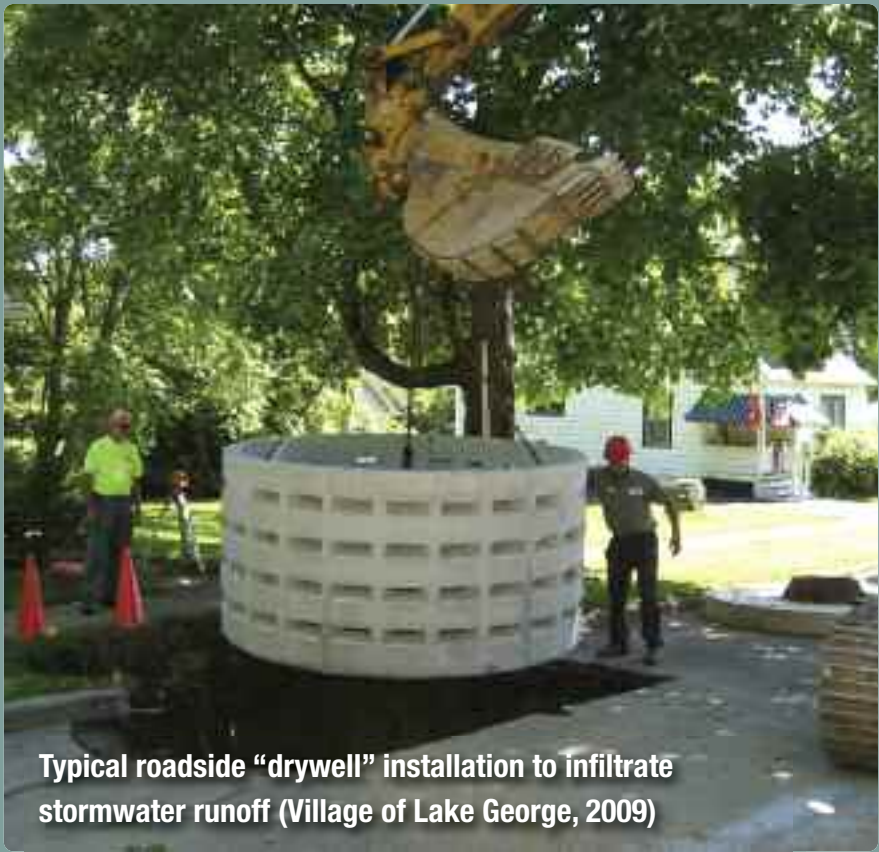
Typical roadside “drywell” installation to infiltrate stormwater runoff (Village of Lake George, 2009)

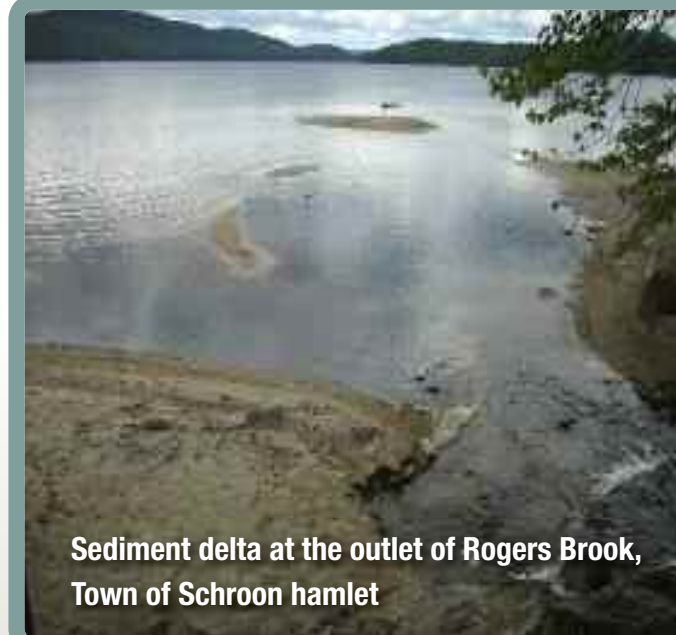
Sediment delta at the outlet of Rogers Brook, Town of Schroon hamlet

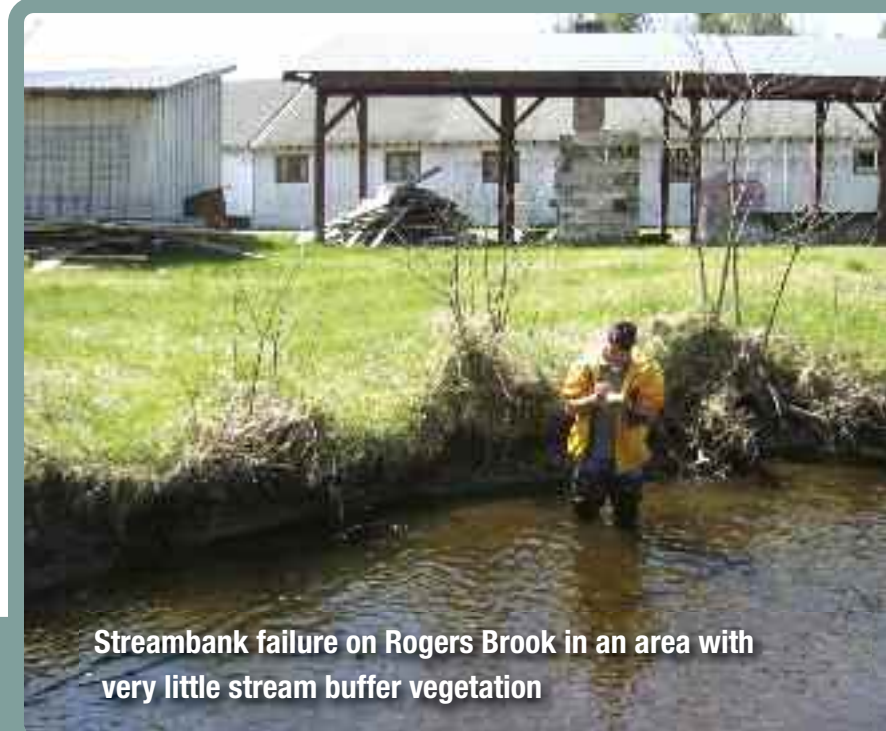
**Streambank failure on Rogers Brook in an area with very little stream buffer vegetation**

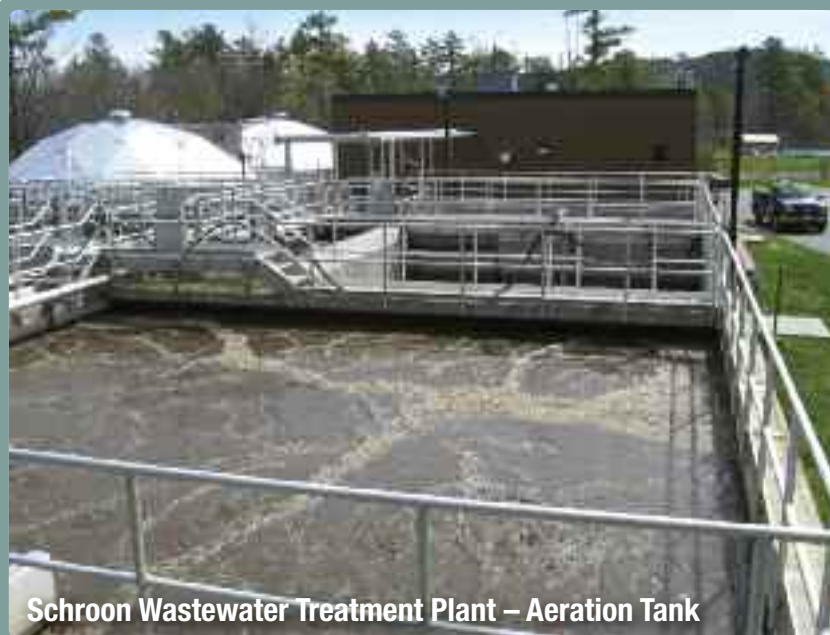
Schroon Wastewater Treatment Plant – Aeration Tank

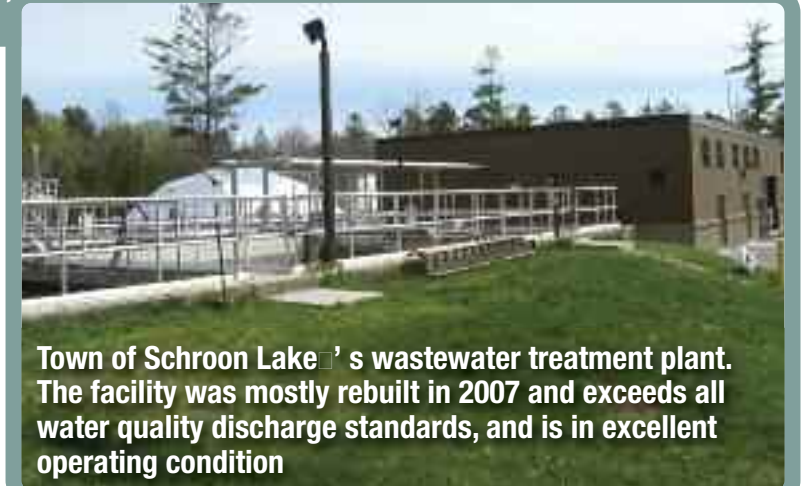
Town of Schroon Lake's wastewater treatment plant. The facility was mostly rebuilt in 2007 and exceeds all water quality discharge standards, and is in excellent operating condition
